MUNICIPALITY OF SOUTH BRUCE

**MUNICIPAL CLASS ENVIRONMENTAL ASSESSMENT
FOR A NEW WATER STORAGE FACILITY
(COMMUNITY OF TEESWATER)**

PROJECT FILE REPORT

May 14, 2025

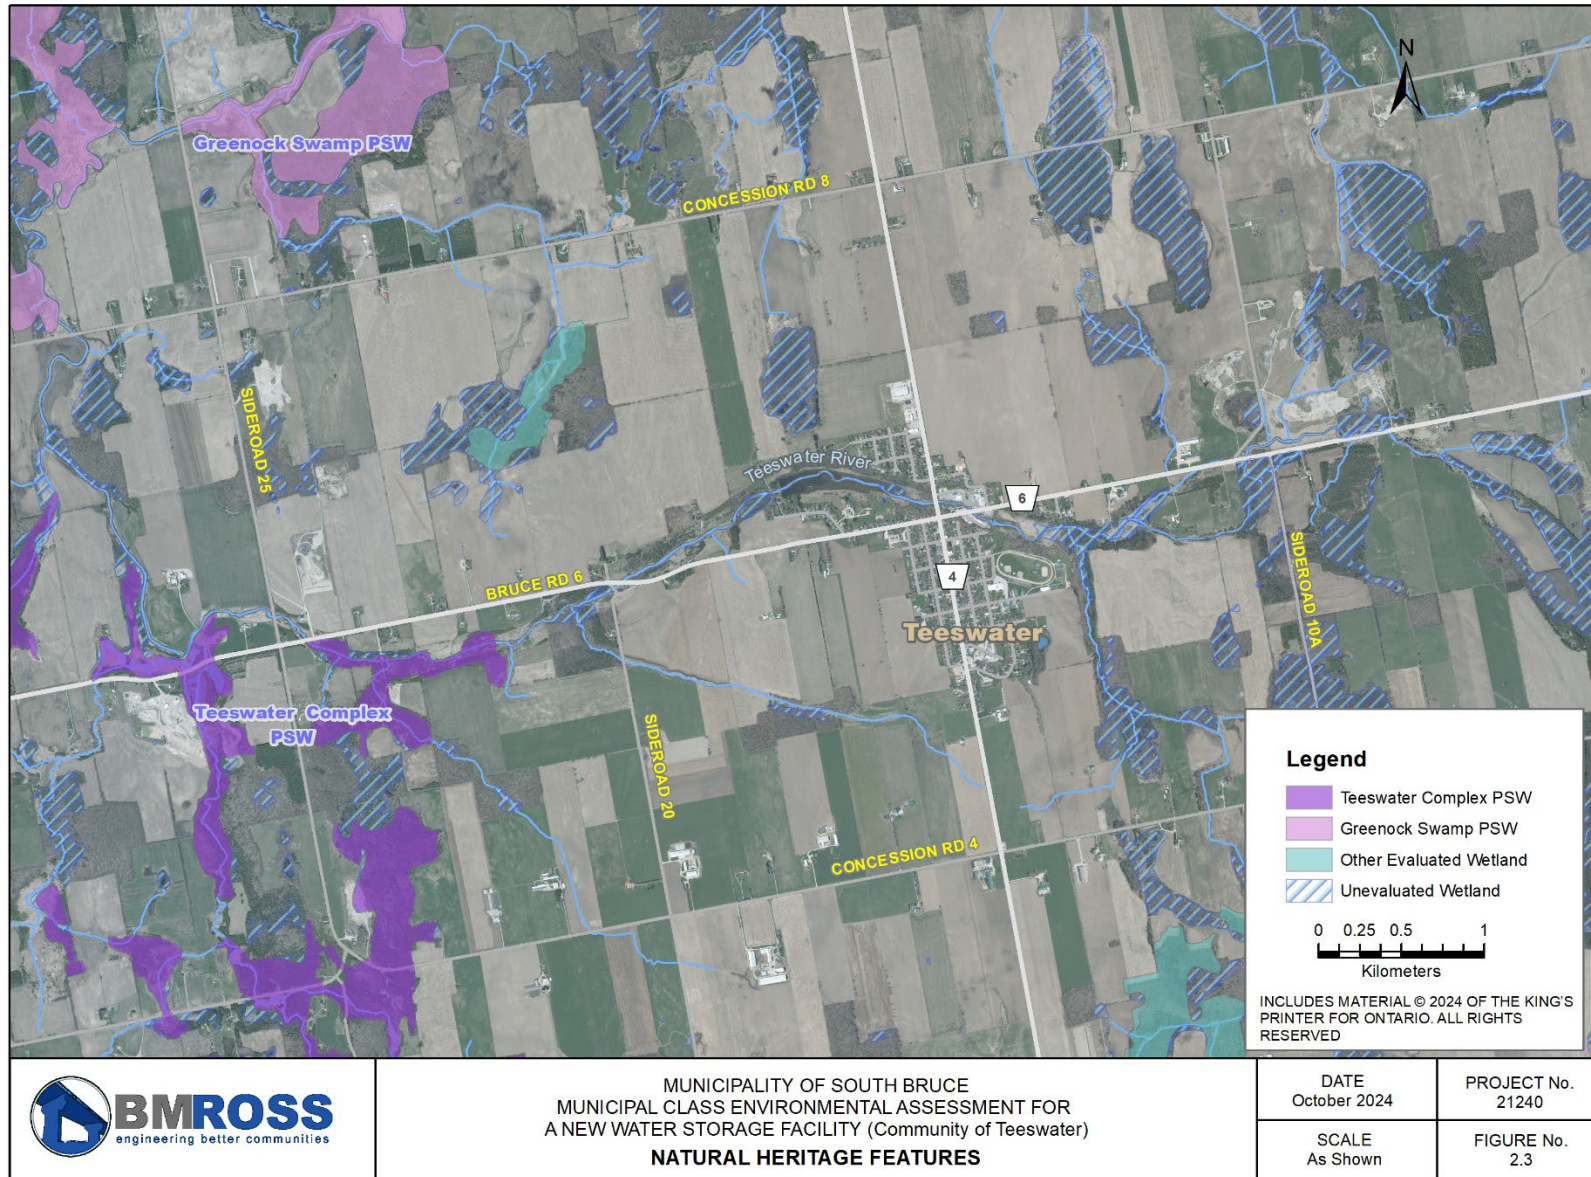
Figure 2.3 Natural Heritage Features

The Natural Heritage Area mapping tool provided by the MNRF was consulted to determine if there are any wetlands within or adjacent to the project study area (the community of Teeswater). The NHIC database was consulted, and no significant wetlands were identified within the community of Teeswater. It is noted that there is the Teeswater Wetland Complex, an evaluated wetland, located 2.5 km west of the study area. Additionally, there is the Greenock Swamp a significant provincial wetland located 4.6 km northwest of the study area. There will be low to no impact on the Teeswater wetland and Greenock Swamp given their distance from the study area. See Figure 2.3 for the location of the natural heritage features.

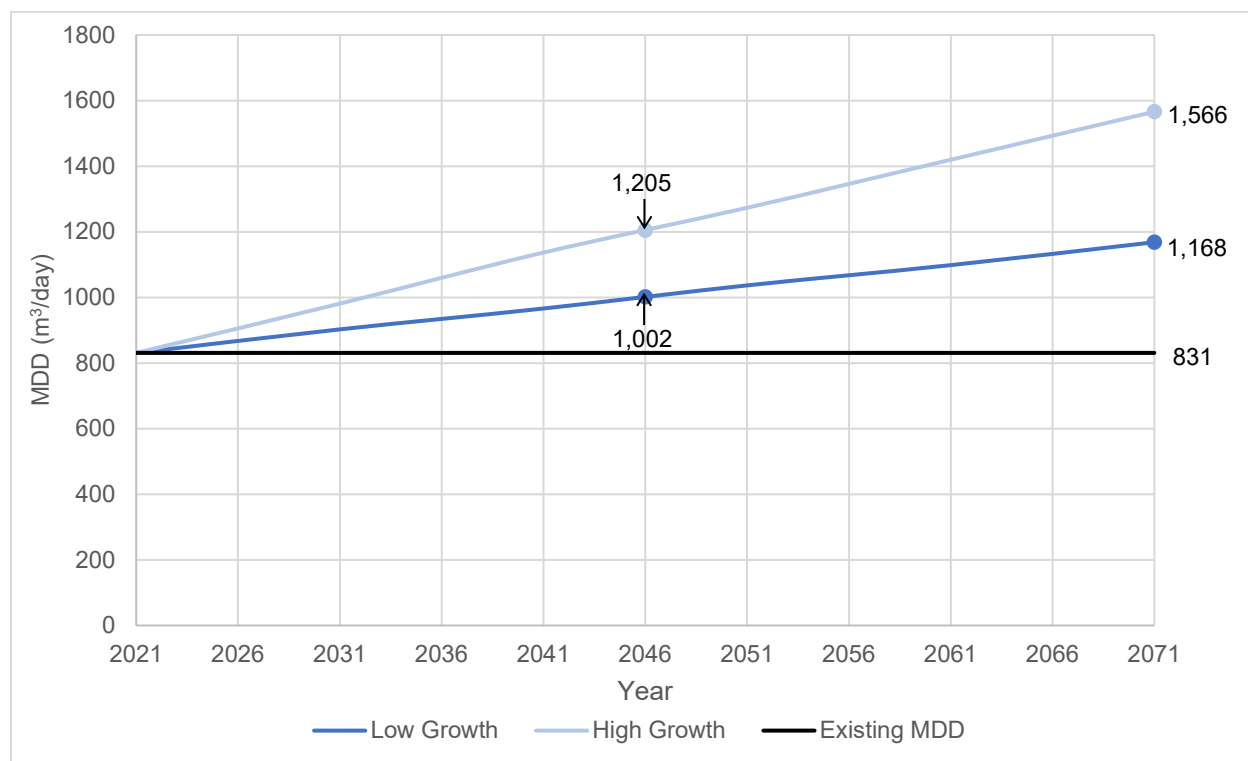
Figure 3.2 Teeswater Projected Maximum Day Demand

Based on Figure 3.2, the 25- and 50-year projected MDDs under the low growth scenario are 1,002 m³/day and 1,168 m³/day, respectively. Under the high growth scenario, the MDDs at 25 and 50 years are 1,205 m³/day and 1,566 m³/day, respectively.

In the last three years, the maximum day demand (MDD) was 831 m³/day, recorded in 2022. The population of Teeswater in 2022 was approximately 1,030. The maximum demand per capita is therefore:

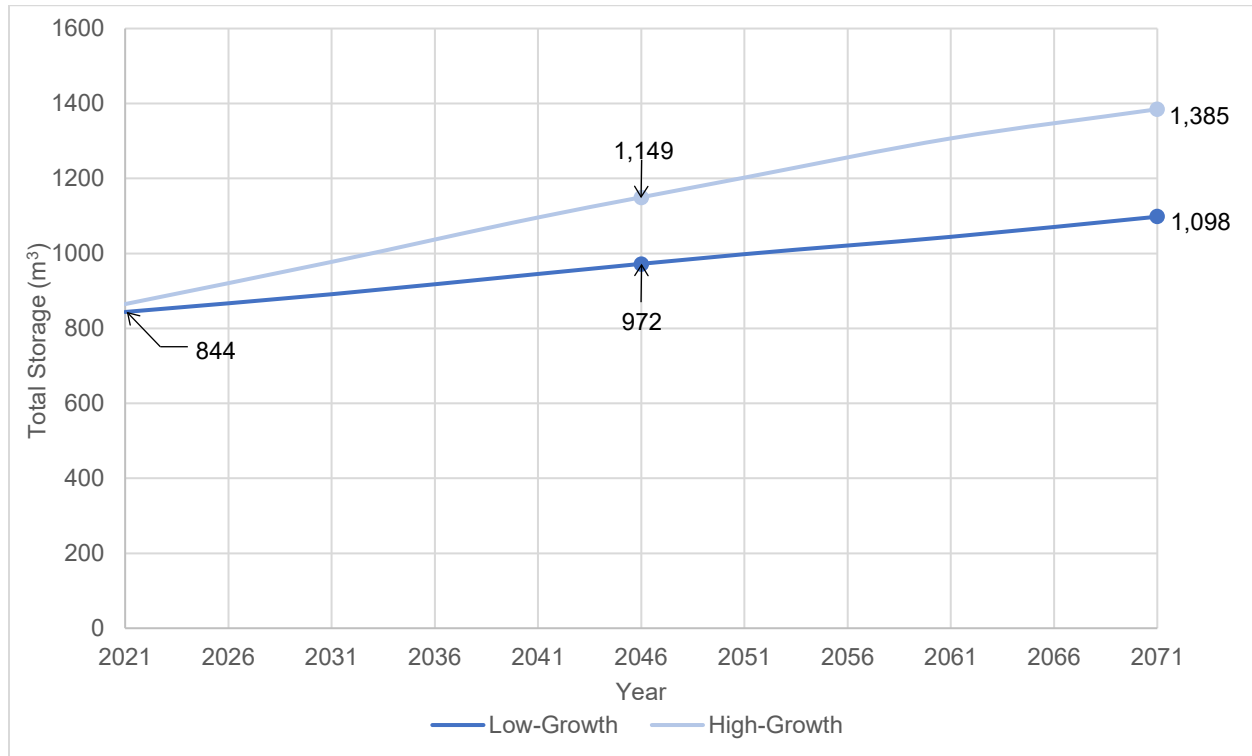
Figure 3.3 Teeswater Projected Water Storage Needs

As shown in Tables 3.4 and 3.5, and Figure 3.3, the existing water storage requirement (i.e., the deficit as Teeswater currently has no storage facilities) is approximately 844 m³. Under the low-growth scenario, the water storage requirement in 50 years is projected to be approximately 1,098 m³. Under the high-growth scenario, the storage requirement is estimated to be around 1,385 m³ by 2071.

As previously stated, Teeswater does not have any treated water storage. Therefore, the storage deficit is equal to the total reported above. Under existing conditions, the deficit is equal to 844 m³. When current commitments are considered, the deficit increases to 1,161 m³. As the population of Teeswater increases, the water demand is anticipated to increase as well. Because any increase in peak demand diminishes the ability of the treatment system to meet that demand, the need for treated water storage is increasingly important.

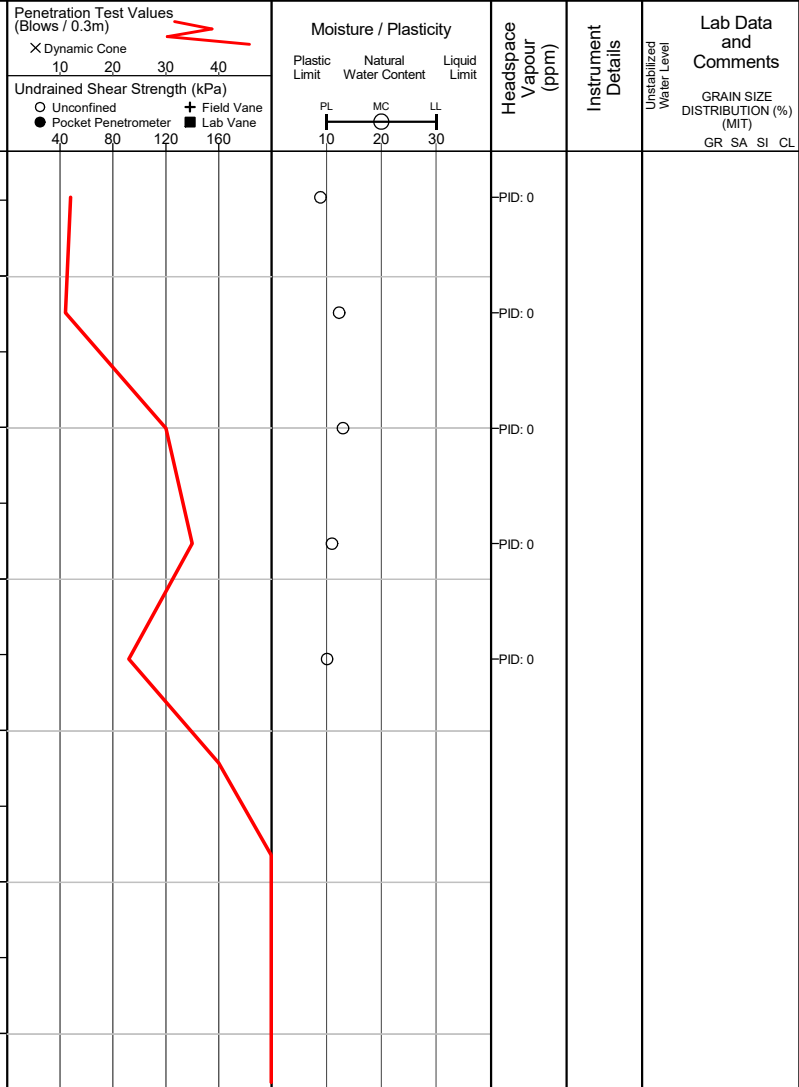
Borehole was dry and open upon completion of drilling.

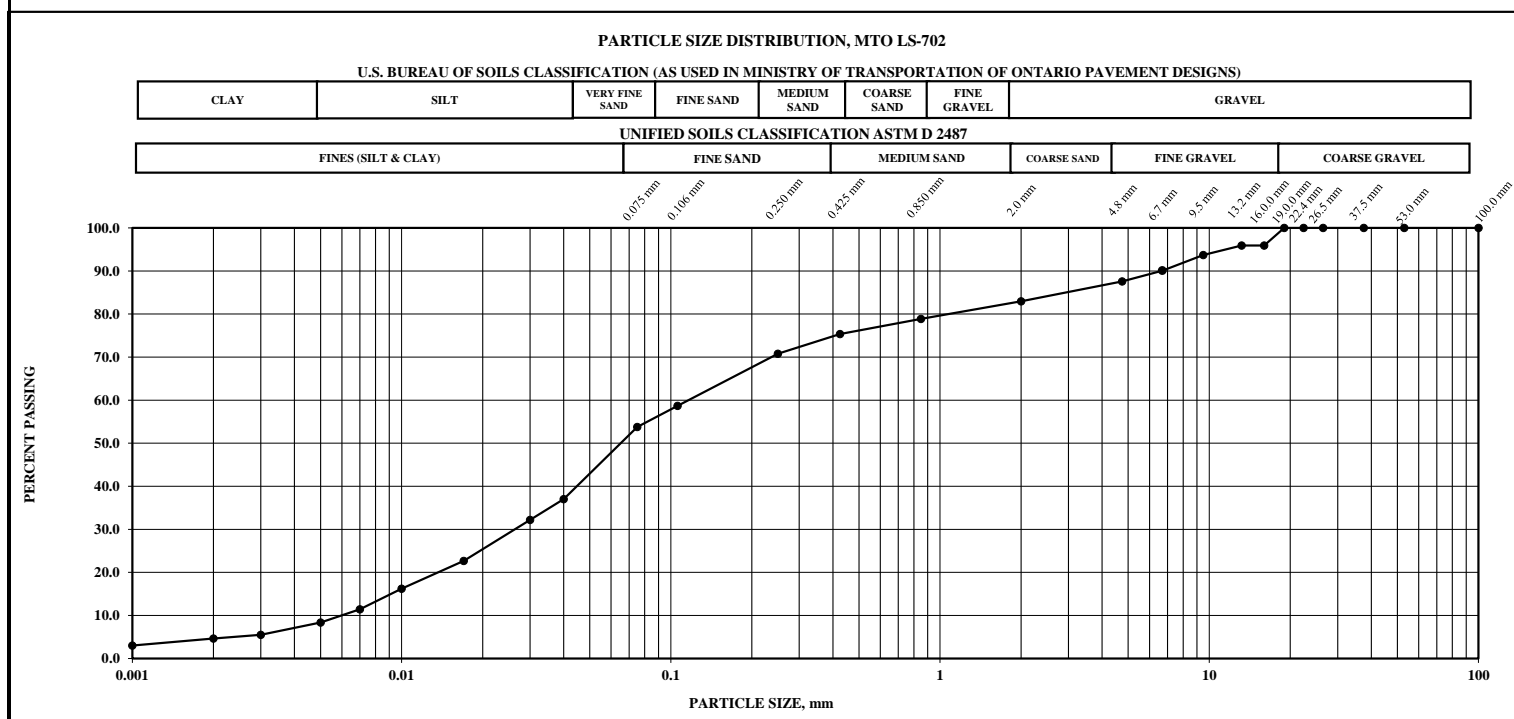
Project Number:	2311345	Project Name:	New Water Tower and Watermain, Teeswater, ON	Client:	BM Ross and Associated Ltd.
ROS:	9985	Sample ID:	Borehole 3-24 - Sample 2	Sample Depth:	1.53 - 1.98m
Sampled By:	Englobe	Date Received:	February 28, 2024	Date Completed:	March 18, 2024
File Number:	04-02311345.000.MT-SH-002-00			Englobe Laboratory	Kitchener

Coefficients									
D60	0.122	D30	0.027	D10	0.006	Cc	0.988	Cu	20.05

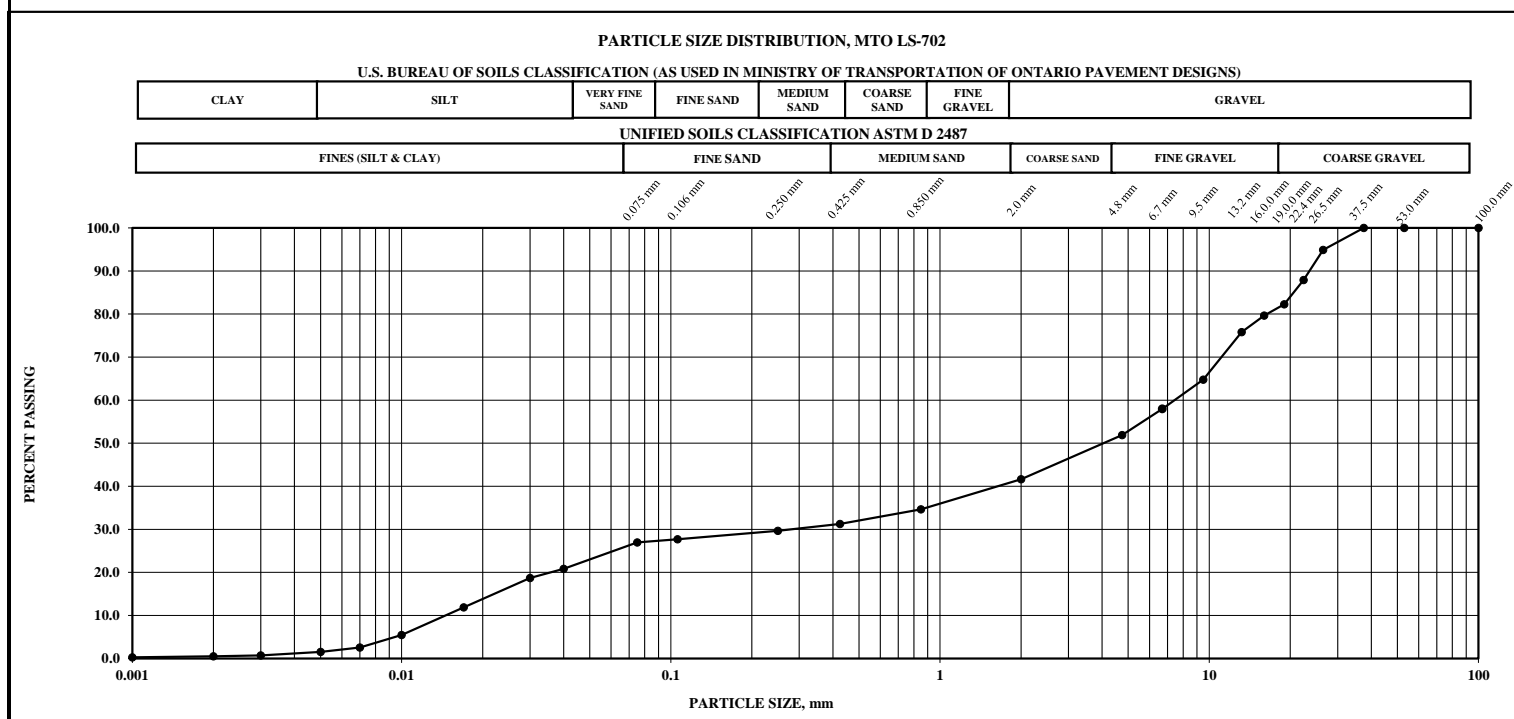
Project Number:	2311345	Project Name:	New Water Tower and Watermain, Teeswater, ON	Client:	BM Ross and Associated Ltd.
ROS:	9987	Sample ID:	Borehole 6-24 - Sample 4	Sample Depth:	3.05 - 3.51m
Sampled By:	Englobe	Date Received:	February 28, 2024	Date Completed:	March 18, 2024
File Number:	04-02311345.000.MT-SH-004-00			Englobe Laboratory	Kitchener

Coefficients									
D60	3.593	D30	0.286	D10	0.015	Cc	1.522	Cu	240.15
